**STATEMENT OF THE PROBLEM**

## OVERALL OBJECTIVE OF THE LOCAL MOUTH MANAGEMENT PROGRAMME

**INTEGRATED ASSESSMENT: UILKRAALS**

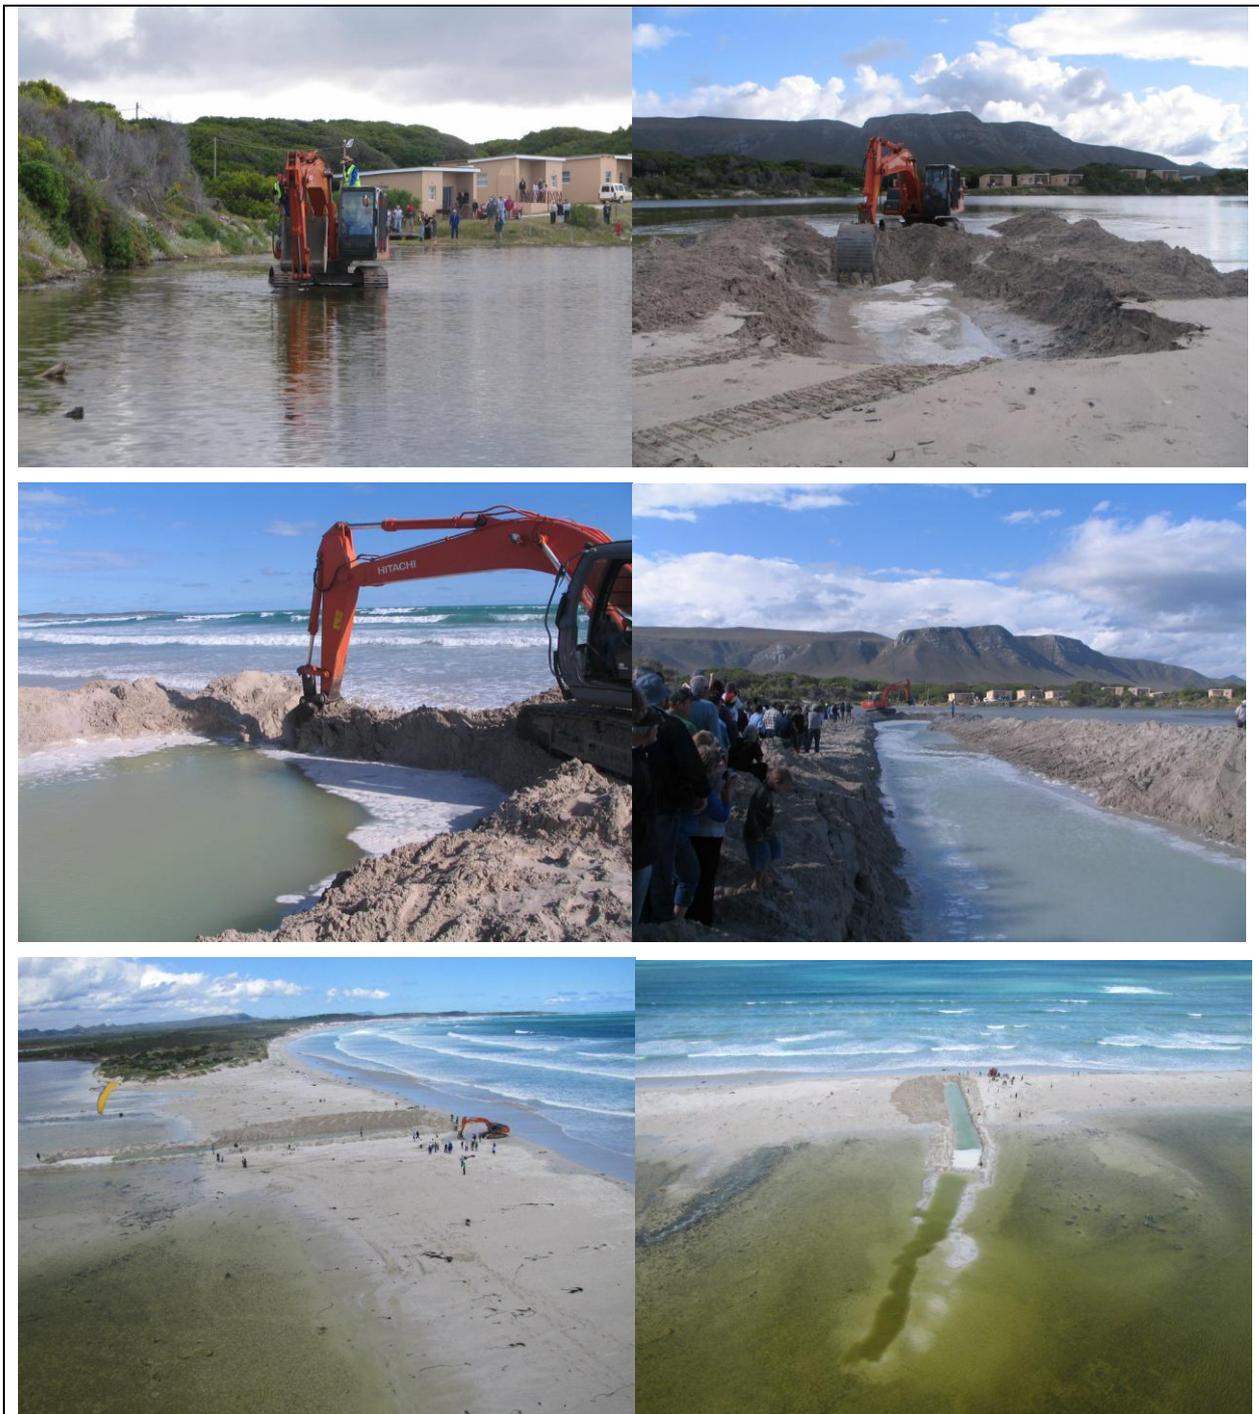
The total channel length was approximately 85 m with a width of 5 m and an average depth of 1 m. An estimated 425m<sup>3</sup> of sand was removed to form the channel.

After the channel was dug (11h30) the excavation was stopped and time was allowed for the high-tide to reach its maximum level at 15h15. Two earth plugs remained in the channel. The first one prevented the water from the lagoon entering the channel while a sea side plug prevented the high tide from entering into the channel.

One hour was allowed for the water to recede after high tide before the final breach took place. At 16h00 the plug in the lagoon was removed and water flooded into the channel up to the sea side of the channel after which the final breach to the sea took place at 16h15.

The water flow after breaching was strong and adequate to ensure a good scouring of the sandbank in the mouth area. By Sunday morning 24 October 2010 the mouth was approximately 60m wide and over 2 meters lower than the original berm height.

The breaching was successful and everyone involved was happy with the outcome. Photographs of the breaching procedure are included below (courtesy of Francois Kotze, Overberg District Municipality).

It is recommended that a similar procedure to that described above be followed in the future and that representative from all the respective agencies (Overberg District Municipality, Overstrand Municipality, Cape Nature) are present during the breaching process.

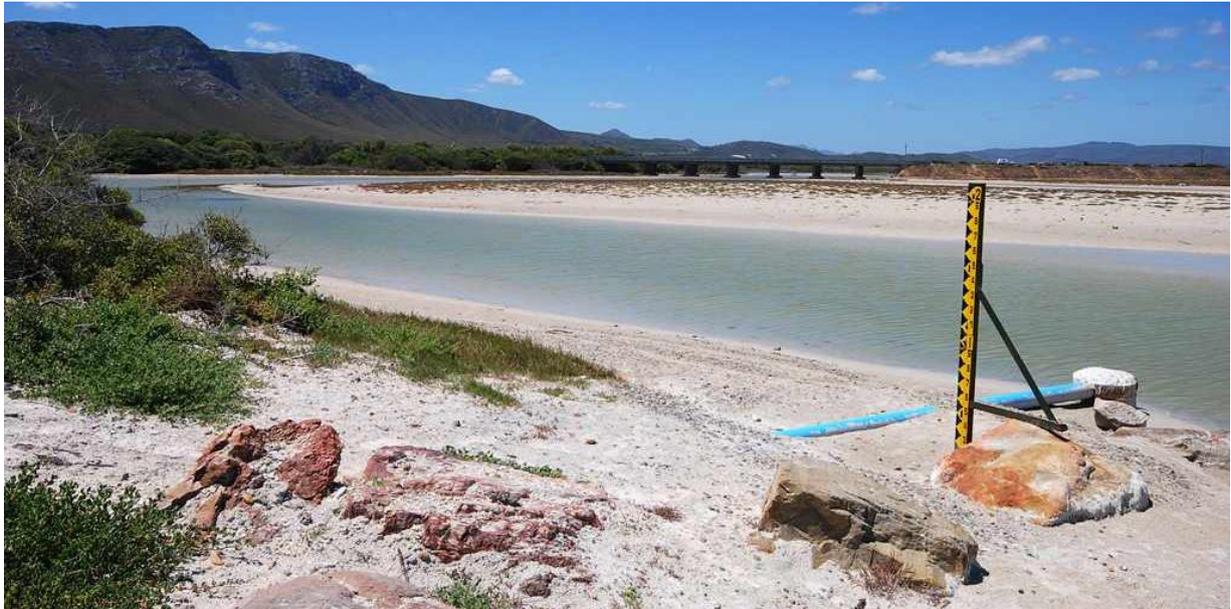
**Figure 1. DWA water level recorder on the Uilkraals estuary (Photo: Sue Mathews)**

MONITORING ACTIONS	LOCAL REQUIREMENT - YES/NO	AGENCY RESPONSIBLE
Mouth condition	Regular (daily) observations and records need to be kept on the state of the mouth of the Uilkraals estuary (open/closed/closed and over topping)	Overberg District Municipality/ Overstrand Local Municipality
Estuarine water level, and initial ocean water level (high-low, spring-neap tide), when breaching should be effected	<p>The Department of Water Affairs has installed an automatic water level recorder at the mouth of the estuary. However, this water level recorder stands high and dry out of the water most of the time and needs to be relocated to a position underneath the road bridge. DWA have agreed to do this.</p> <p>Until such time that the recorder is operational, manual readings should be taken at the Road Bridge as frequently as possible. These levels are used to determine whether rising water to levels that present a flooding risk.</p> <p>Water level constraints:</p> <ul style="list-style-type: none"> <li>• Flooding - occurs at 1.3m amsl and above.</li> </ul>	Department of Water Affairs (DWA)
