## **APPENDIX 13: Geotechnical Assessment**

Technical Report  
2025 / 03 / 22 / GTEC

## EAST LONDON PORT DESALINATION PLANT

Geotechnical investigation in support of feasibility study for the proposed Solar Powered Desalination plant and related infrastructure at the East London Harbour, Buffalo City Metropolitan Municipality, Eastern Cape

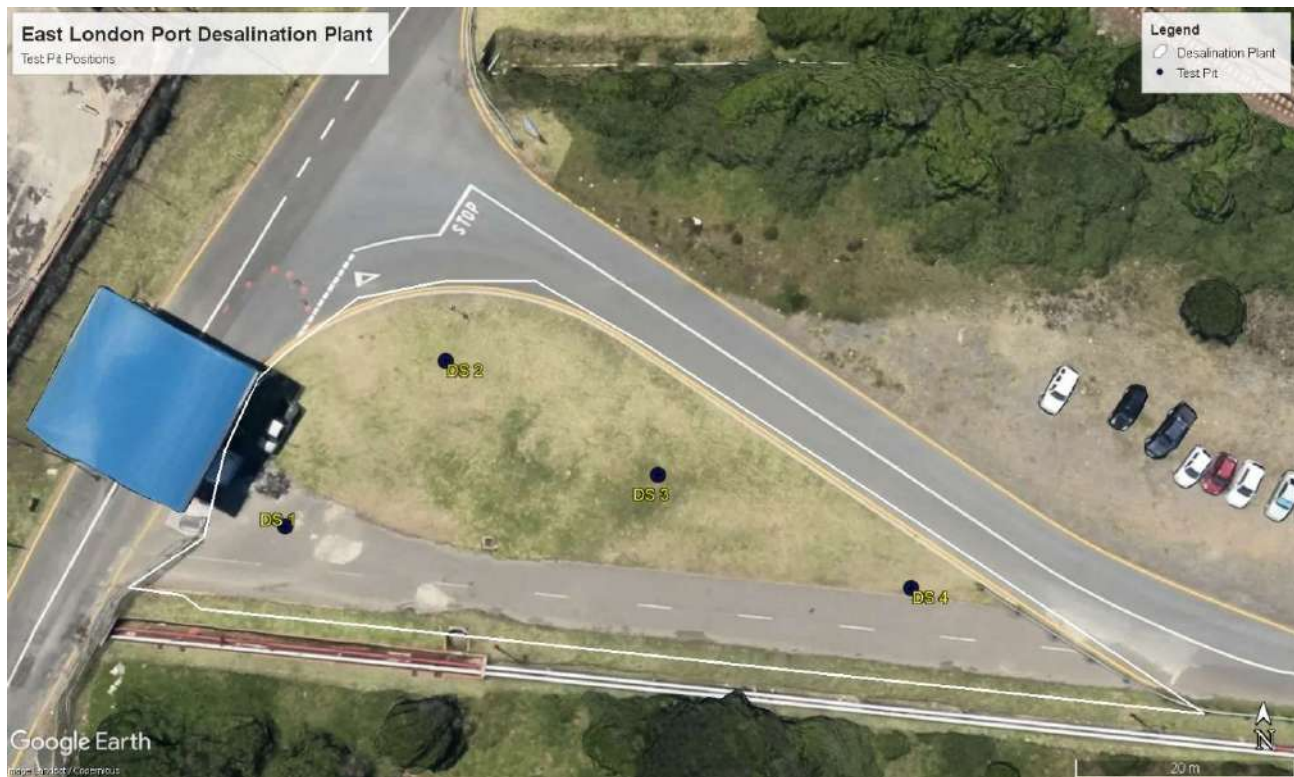
Figure 4: Test pit layout – Desalination Plant

A total of four (4) trial pits, numbered DS 1 to DS 4 were excavated utilising a CAT 426 4x4 TLB-type excavator on the 4<sup>th</sup> of February 2025 with pit positions indicated in the figure below. Test pits were generally excavated to a depth of 3.00 mbgl or refusal. Profiling of the trial pits were conducted according to the Guidelines for Soil and Rock Profiling in South Africa (Sept 2008).

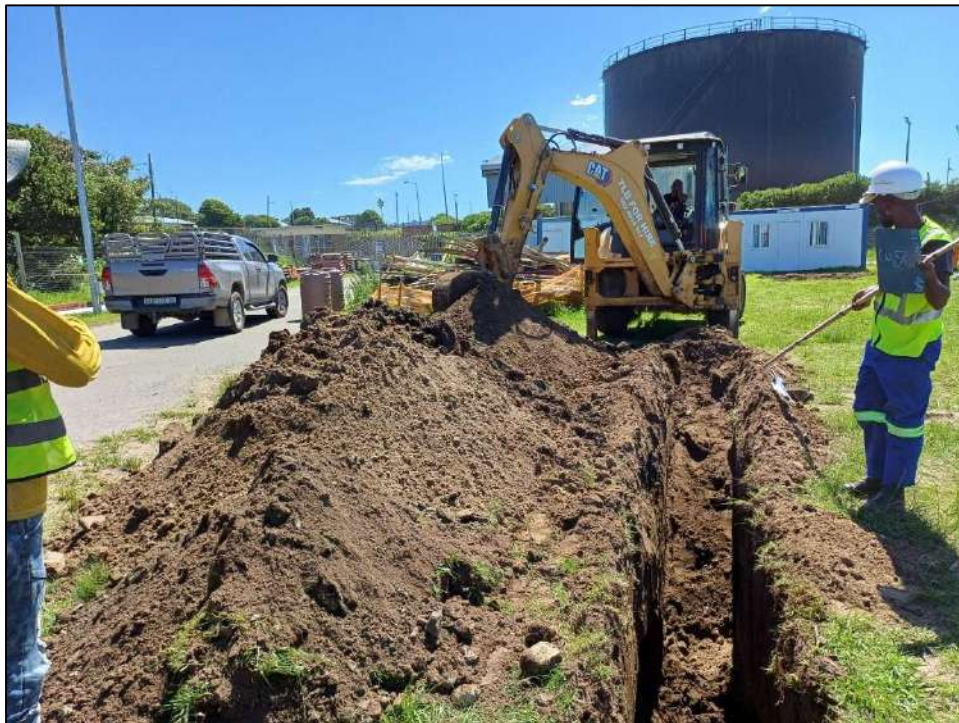
Photo 1: Test pit excavation on DS 3

The proposed desalination plant site is generally covered by fill material that is likely related to previous construction activities (road construction). The imported soil material is generally composed of abundant angular gravel to cobbles loosely packed in a matrix of silty sand to sandy clay. This imported soil horizon was found to be highly variable in composition and highly collapsible with sidewall collapse / overbreak

observed in most test pits. The material has a thickness of between 0.70 m and in excess of 3.00 m in portions of the site.

The imported soils are underlain by transported aeolian soil material in the form of dune sand. The dune sand exhibits an intact soil structure with a loose to very loose consistency and a thickness of up to 1.60 mbgl.

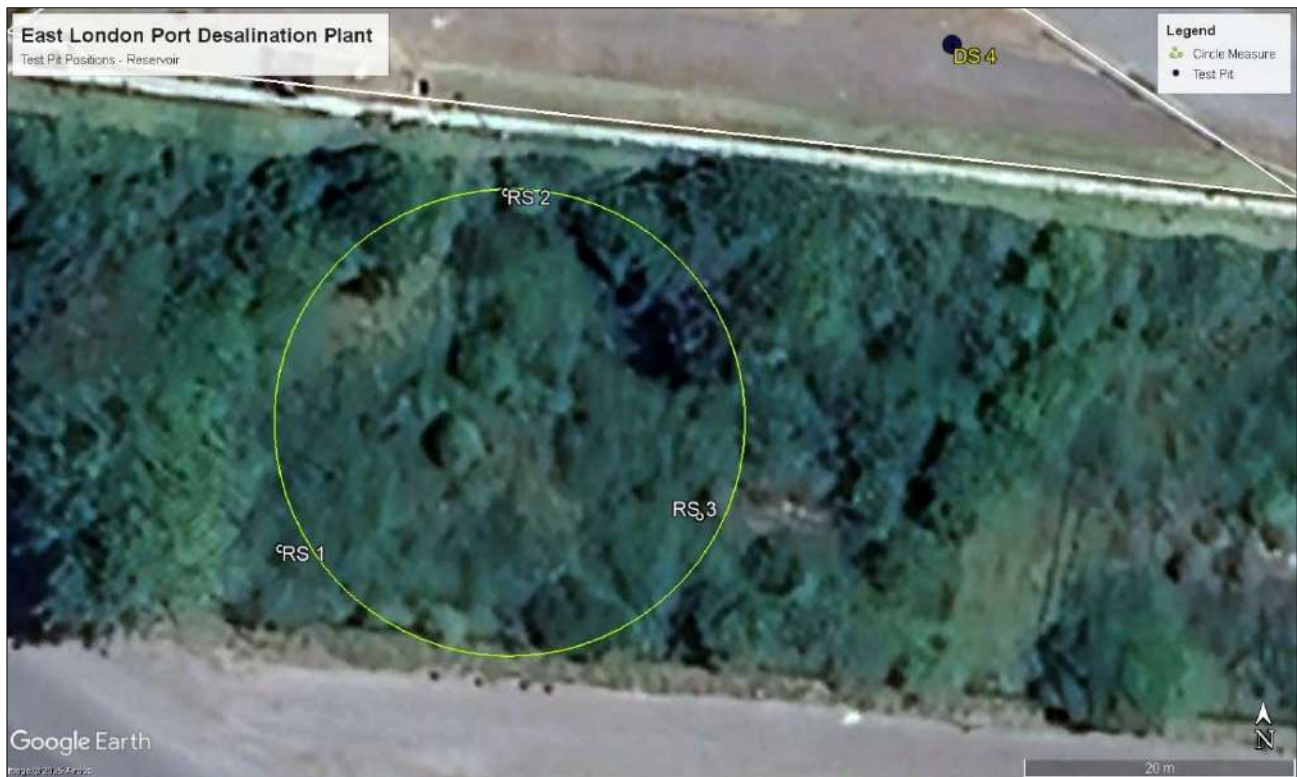
Figure 6: Reservoir– Trial Pit Layout

A total of three (3) trial pits, numbered RS 1 to RS 3 were excavated utilising a CAT 426 4x4 TLB-type excavator on the 5<sup>th</sup> of February 2025 with pit positions indicated in the figure below. Test pits were generally excavated to a depth of 3.00 mbgl or refusal. Profiling of the trial pits were conducted according to the Guidelines for Soil and Rock Profiling in South Africa (Sept 2008).

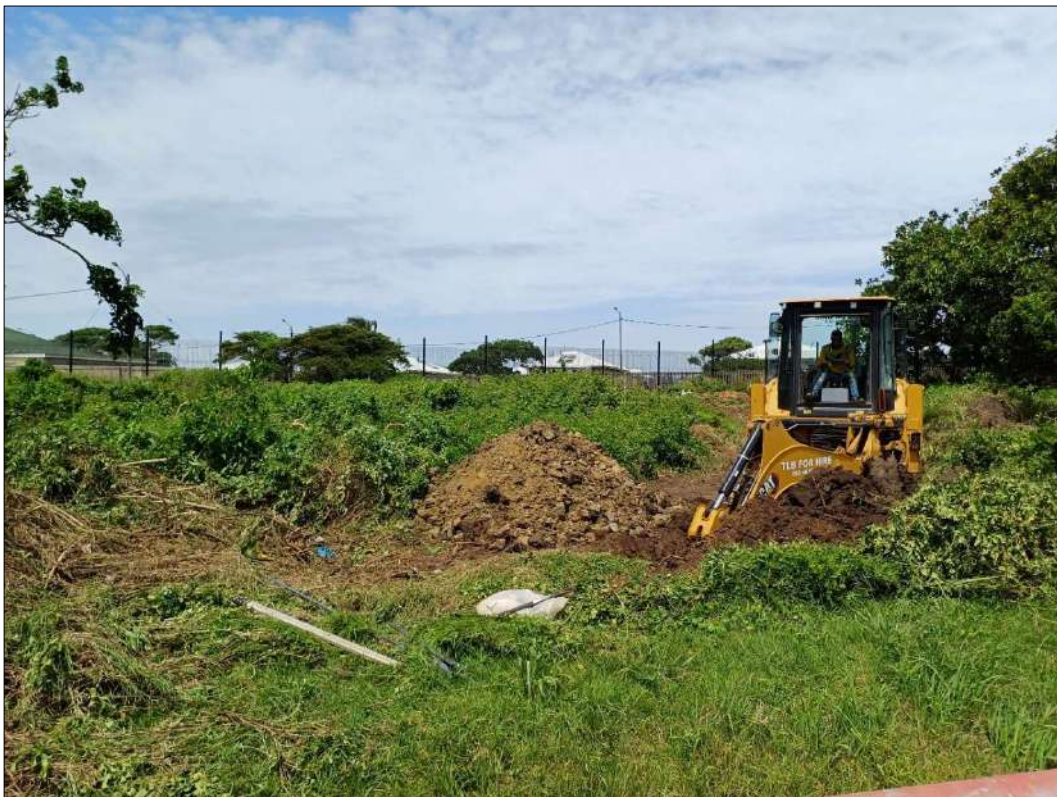
**Photo 2: Test pit excavation on the Reservoir position**

The site is generally covered by Fill material that is likely related to previous construction. The imported soil material is generally composed of silty sand to sandy clay with frequent to abundant gravel, bricks and cobbles and rubble. This imported soil horizon was found to highly variable in composition and highly collapsible with sidewall collapse/ overbreak observed in most test pits. The material has a thickness up

Siltstone bedrock was encountered in 2 of the 3 test pits. The bedrock material is highly to moderately weathered, very fine grained, thinly jointed and highly fractured with a soft rock to hard rock hardness. The bedrock material was encountered from a depth of 1.10 to 2.20 mbgl (mean 1.77 mbgl).

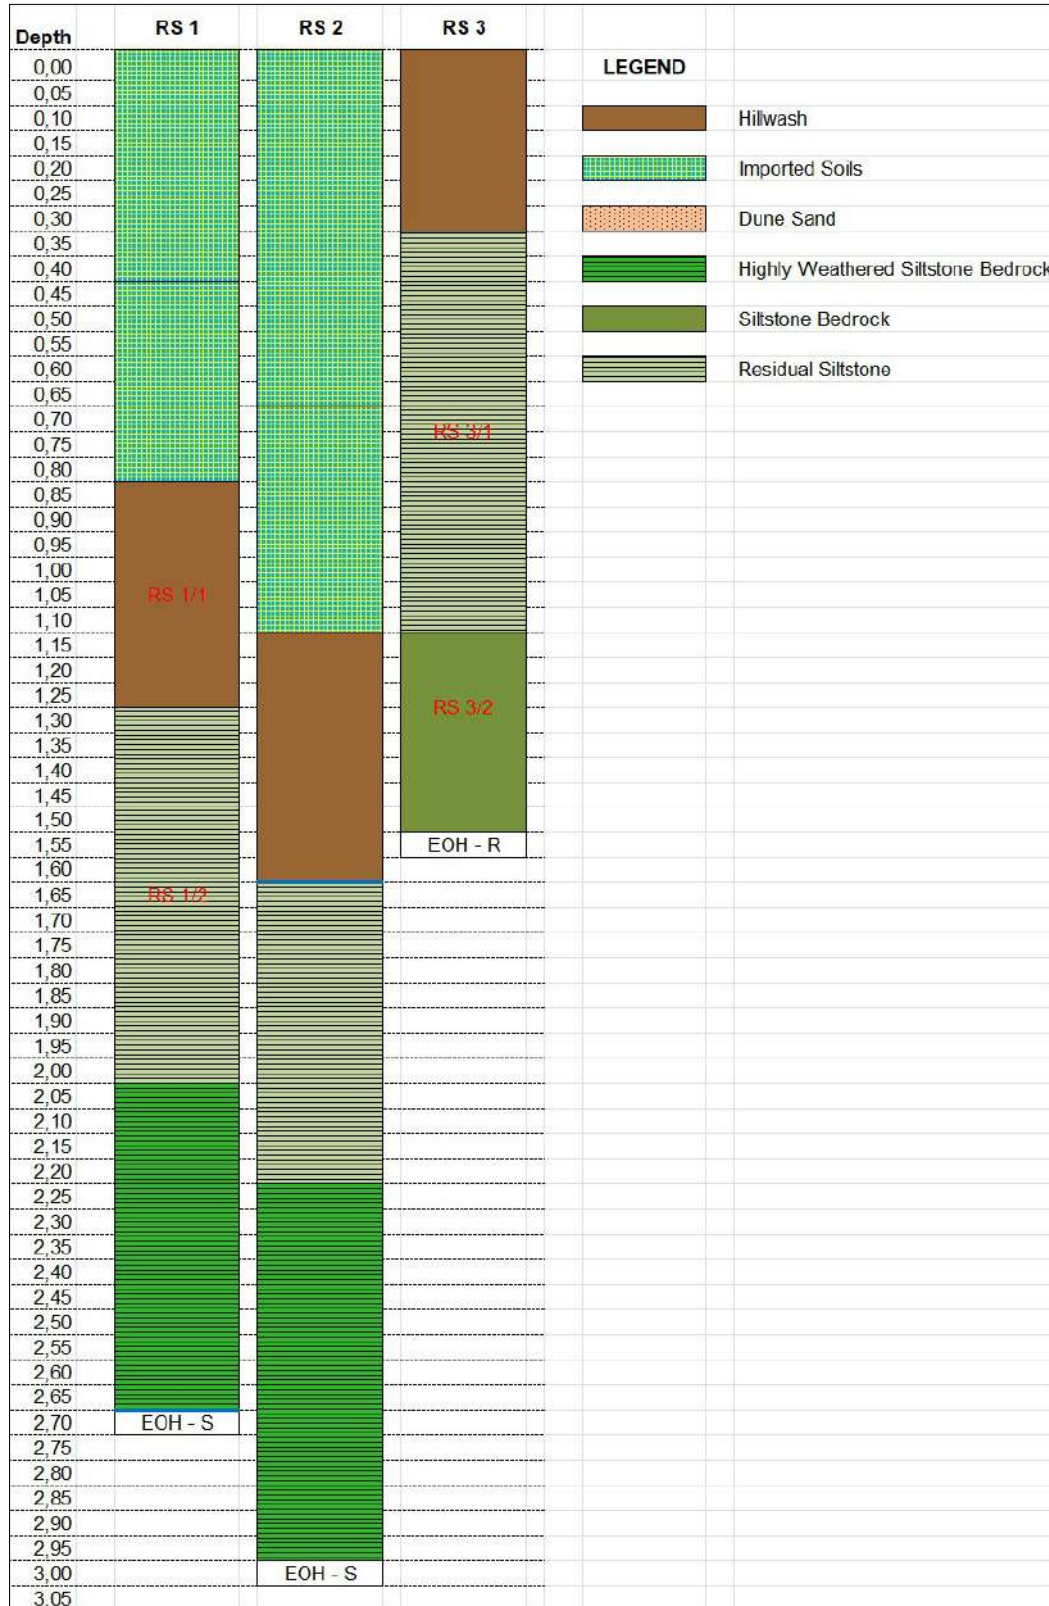
Figure 7: Conceptual Soil Profile - Reservoir

Detailed test pit logs and photographs are attached in Appendix B-1. The generalised soil profile the site is indicated in the Figure below.

- ❑ The imported, hillwash and residual siltstone materials are deemed to highly compressible / collapsible with a calculated collapse / compress in greatly excess of 10 mm. This material is not suitable for founding and should be removed.

- ❑ The following foundation options can be considered for the proposed desalination plant:
  - The fill, hillwash and residual siltstone materials have to be stripped to spoil.

- Foundation options that can be considered and discussed include but is not limited to the following:

- Engineered Fill / Rockfill mattress.
  - Raft foundations.
  - Piled or pier foundations on competent bedrock material.
- 
- It is recommended that an efficient surface water drainage system be installed around the structure to ensure that moisture contents in the soils near foundations are kept stable. Water seepage and ponding will result in differential movement of the structure.

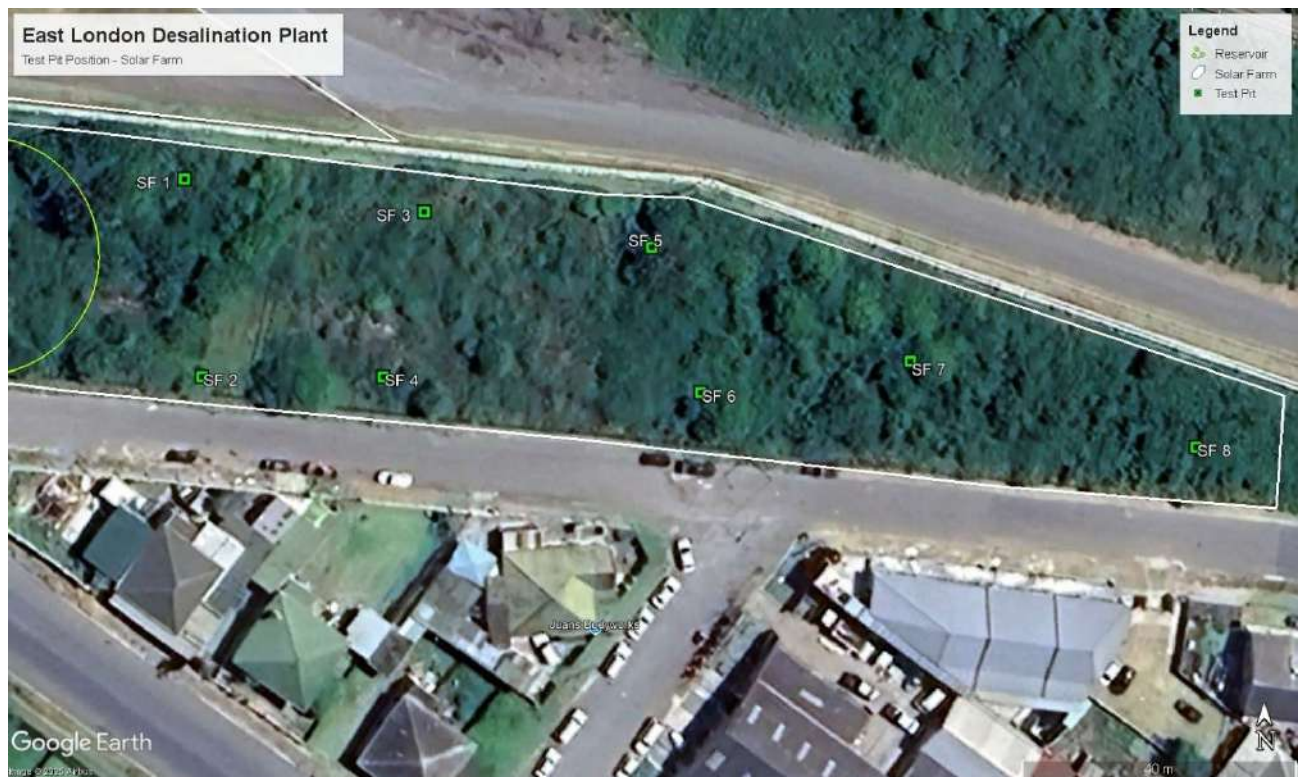
Figure 8: Solar Farm – Trail Pit Layout

A total of eight (8) trial pits, numbered SF 1 to SF 8 were excavated utilising a CAT 426 4x4 TLB-type excavator on the 5<sup>th</sup>, 8<sup>th</sup> and the 18<sup>th</sup> of February 2025 with pit positions indicated in the figure below. Test pits were generally excavated to a depth of 3.00 mbgl or refusal. Profiling of the trial pits were conducted according to the Guidelines for Soil and Rock Profiling in South Africa (Sept 2008).

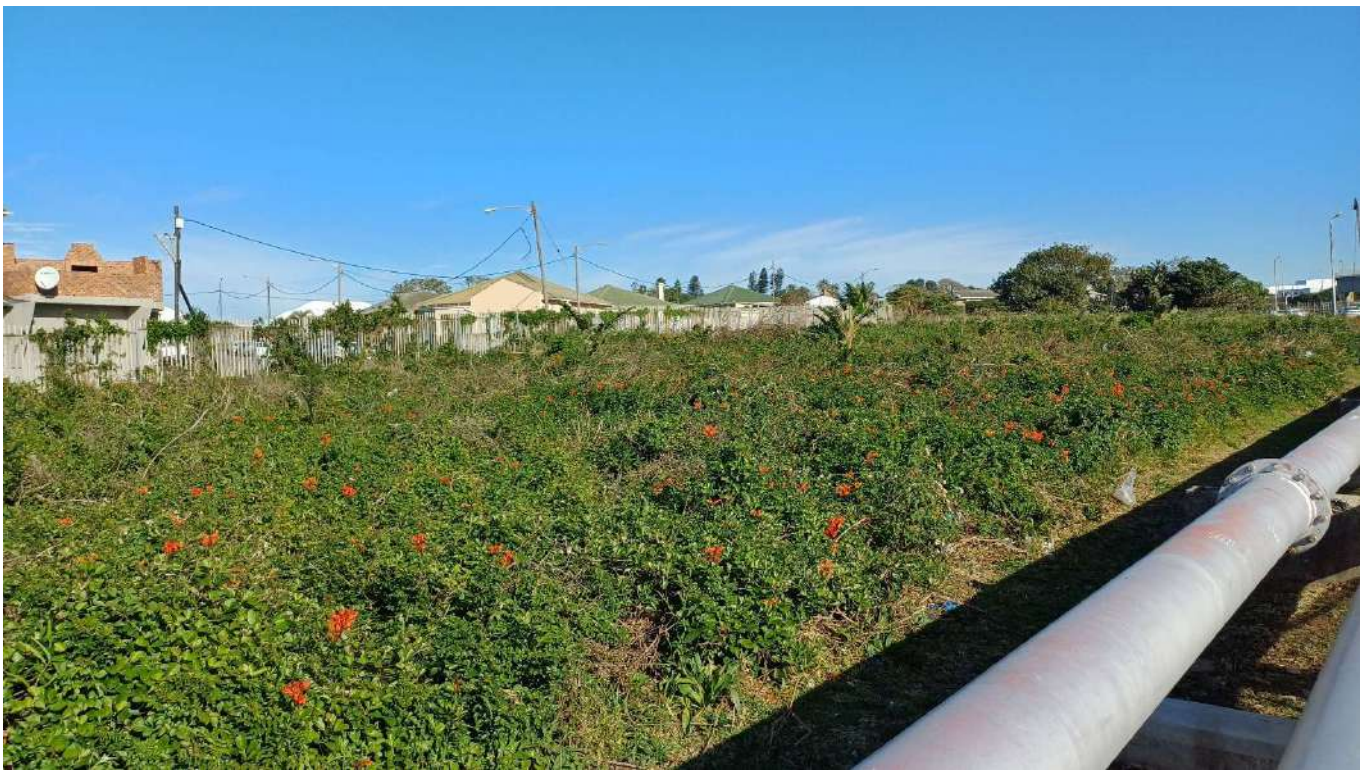
Photo 3: Site conditions - Solar Farm

The site is generally covered by fill / spoil material that is likely related to previous construction. The imported soil material is generally composed of silty sand to sandy clay with frequent to abundant gravel, bricks and cobbles. This imported soil horizon was found to highly variable in composition and highly collapsible with sidewall collapse/ overbreak observed in most test pits. The material has a thickness of
